NRL Report 5920

Fracture Analysis Diagram Procedures for the Fracture-Safe Engineering Design of Steel Structures

W. S. PELLINI AND P. P. PUZAK
Metallurgy Division

March 15, 1963

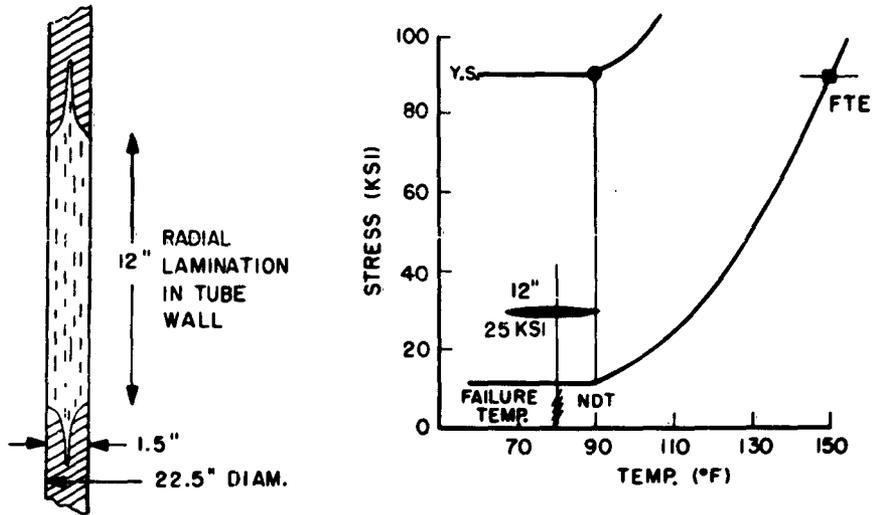
Fig. 51 - (Case C3) Fracture analysis relating to the air-leak test failure of an ASTM A372-IV high pressure air flask

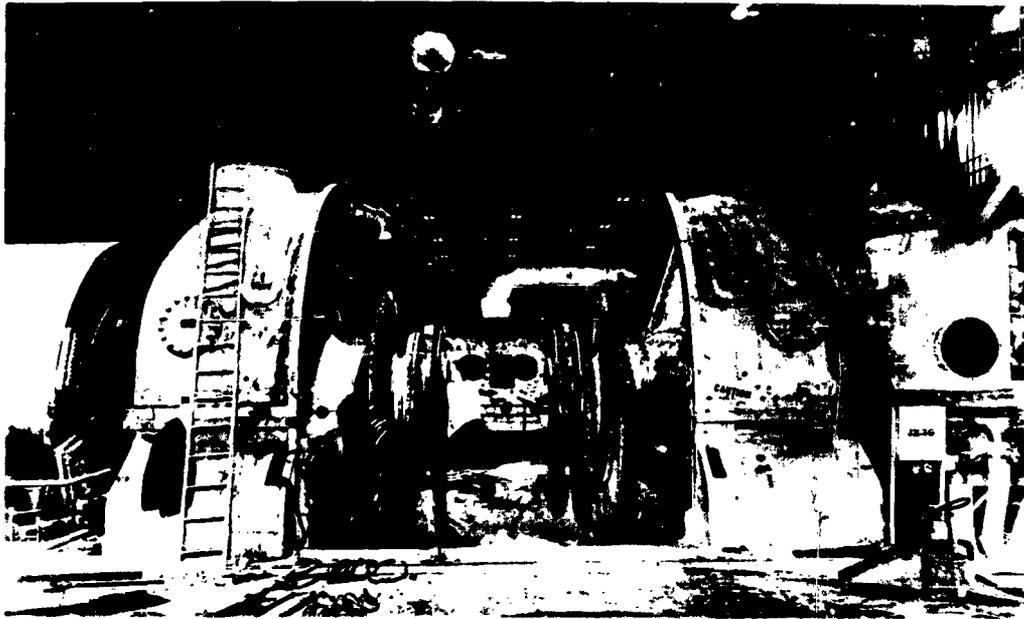
Fig. 52 - (Case C4) Remains of a turbine spindle following fracture and ejection of the 7-ft-diameter center section

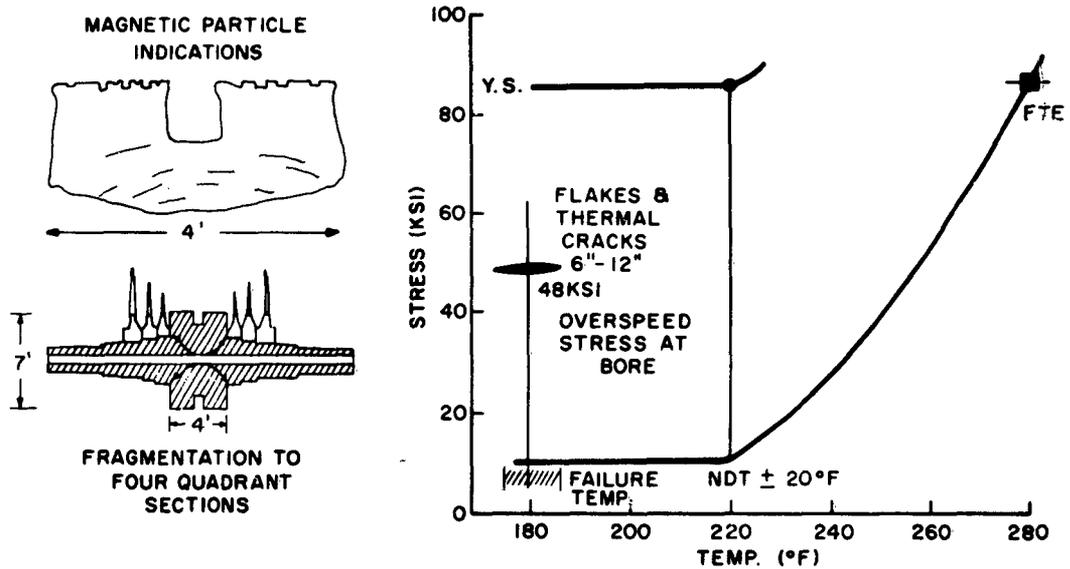
Fig. 53 - (Case C4) Fracture analysis relating to the overspeed failure of the ASTM A293 turbine spindle forging

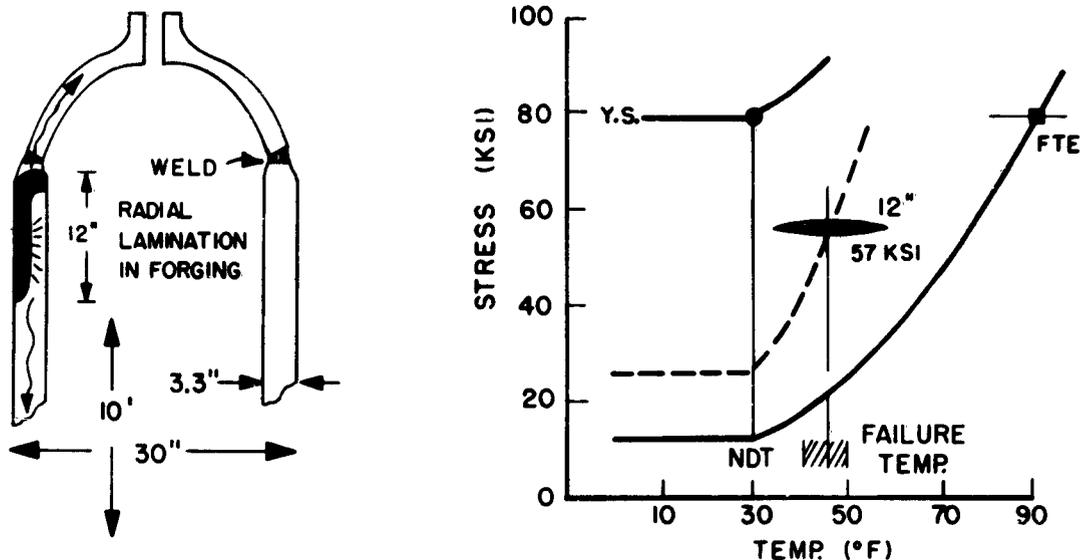
Fig. 55 - (Case D1) Fracture analysis relating to the hydrotest failure of the ASTM A302-B gas flask

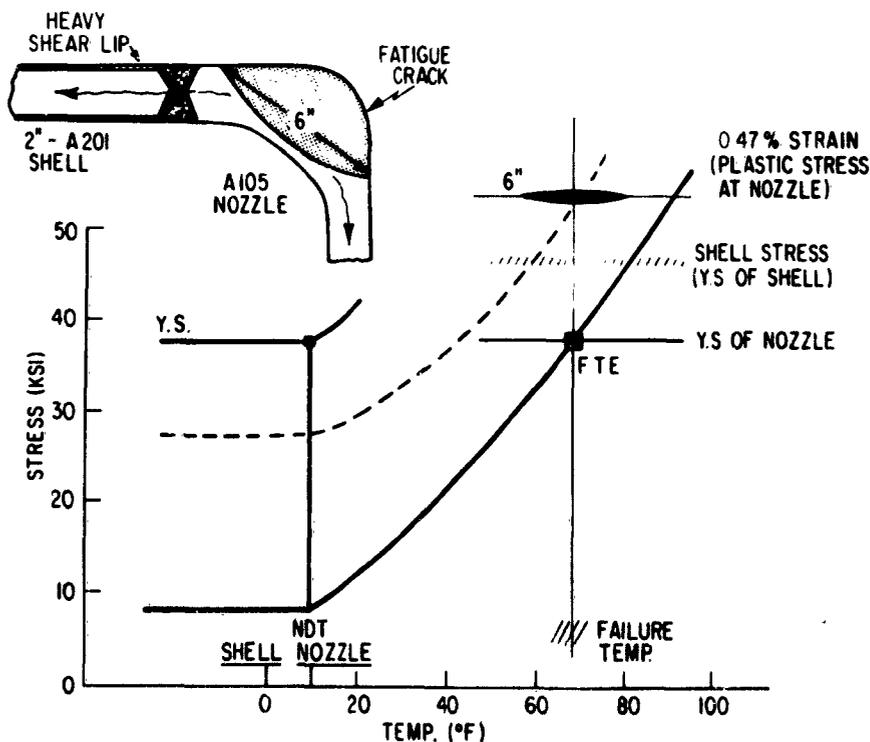
Fig. 58 - (Case E1) Fracture analysis relating to the failure of the PVRC #1 vessel which originated from a 6-in. fatigue crack in a forged ASTM A105 nozzle

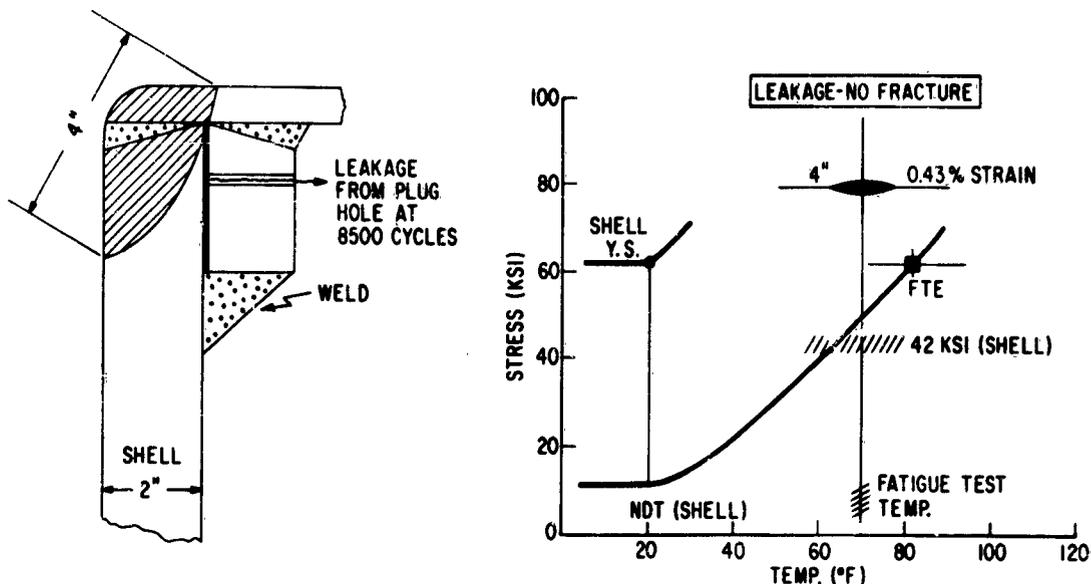
Fig. 61 - (Case E3) Fracture analysis of the flaw size and stress conditions that were inadequate for fracture initiation in the A182-F1 forged nozzle of the PVRC #3 pressure vessel

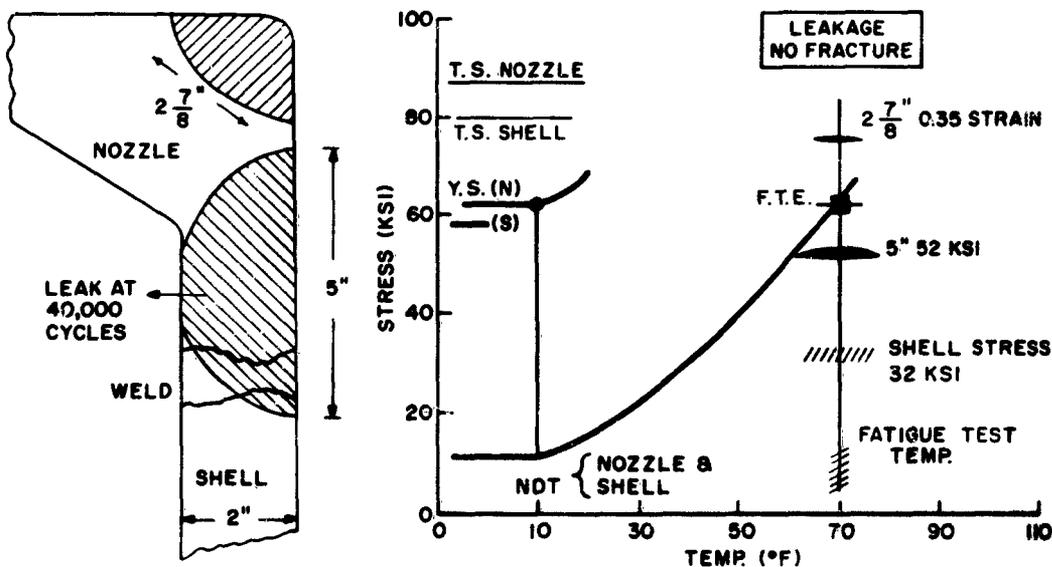
Fig. 63 - (Case E4) Fracture analysis of the flaw size and stress conditions that were inadequate for fracture initiation in the ASTM A182-F1 nozzle and the ASTM A302-B shell of the PVRC #4 vessel

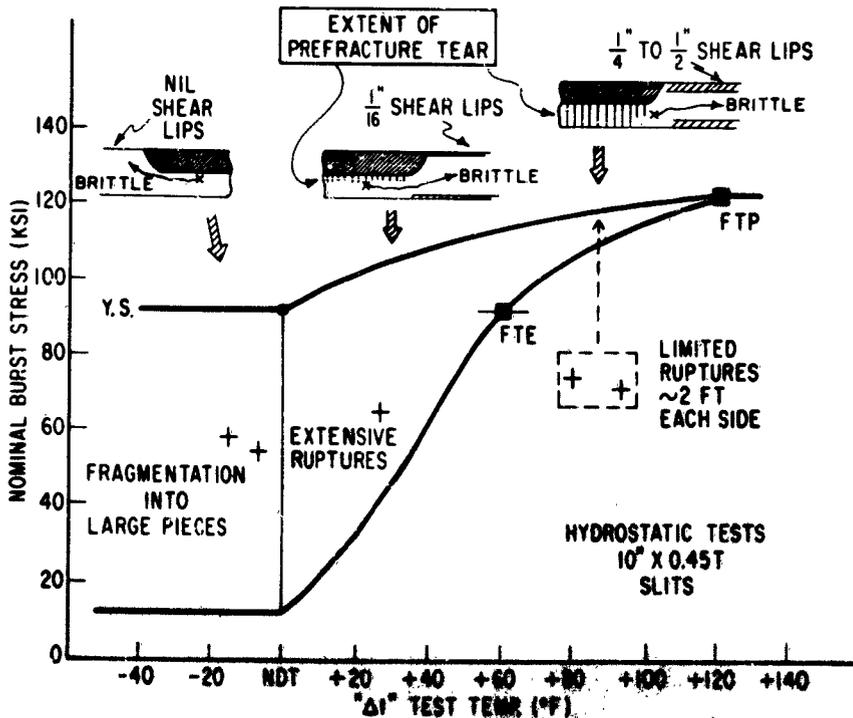
Fig. 64 - (Cases F1 to F5) Summary of hydrostatic burst test data

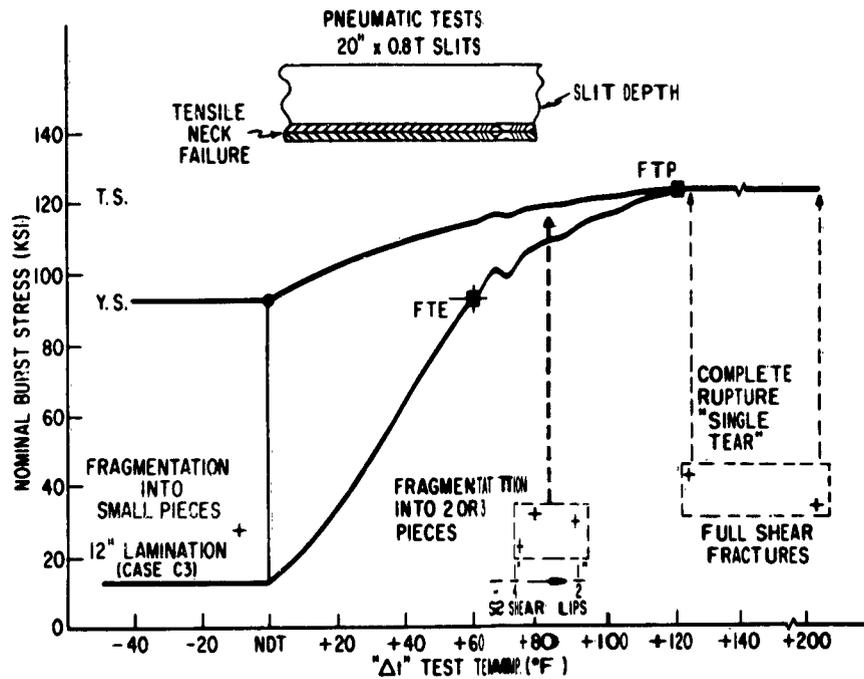
Fig. 66 - (Cases F6 to F11) Summary of pneumatic burst test data

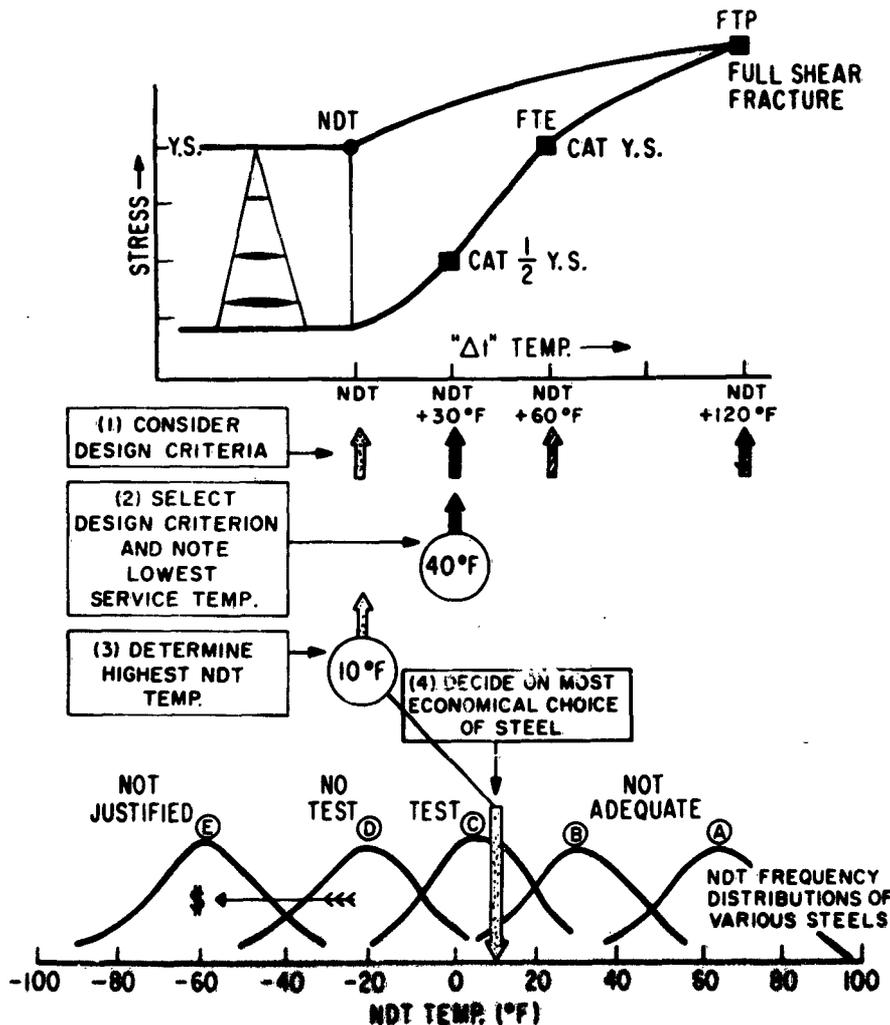
Fig. 68 - An example illustrating the four simple steps for the engineering selection of fracture-safe steels based on the fracture analysis diagram concepts and a catalog of NDT data.
